UTTER PRECISION, INC.

Vibration Case Study on a

Precision CNC Machine

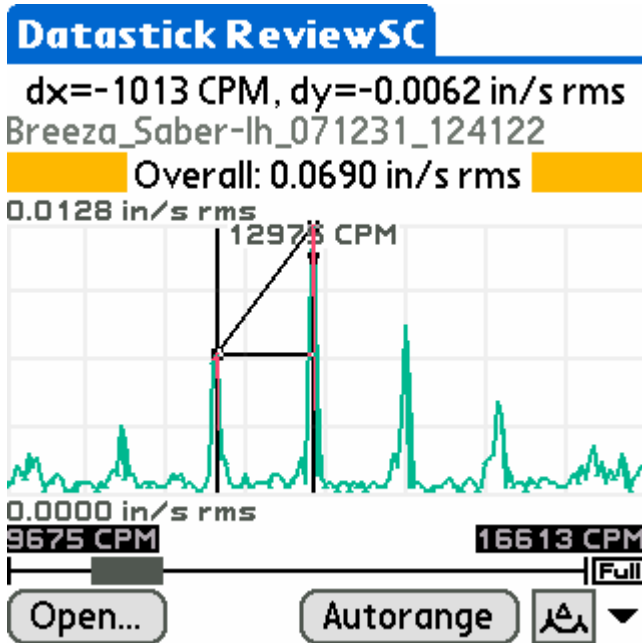
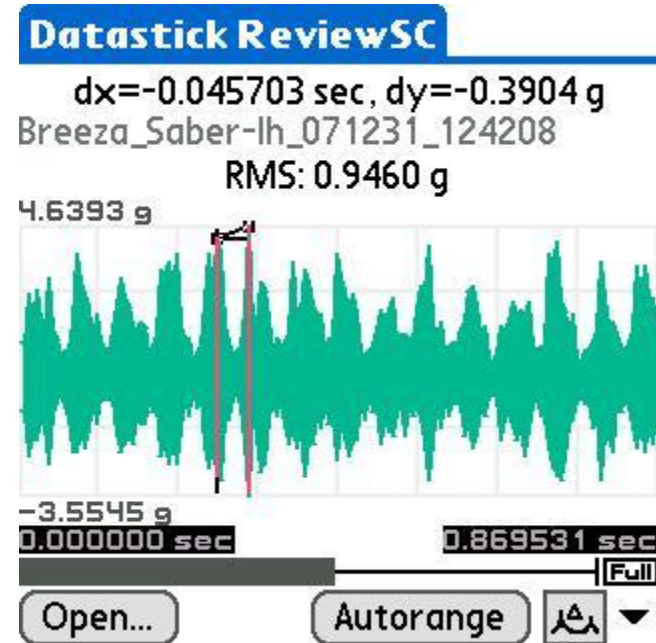
Actual Analysis From Treo

Vibration Data at 12975CPM is the Inner Race Bearing Fault of the Lower Bearing. The Cursor in the spectrum shows the turning speed side banding present. Impacting of greater than 7Gs at this slow of a speed shows the issue is severe.

Replace the spindle bearings ASAP.

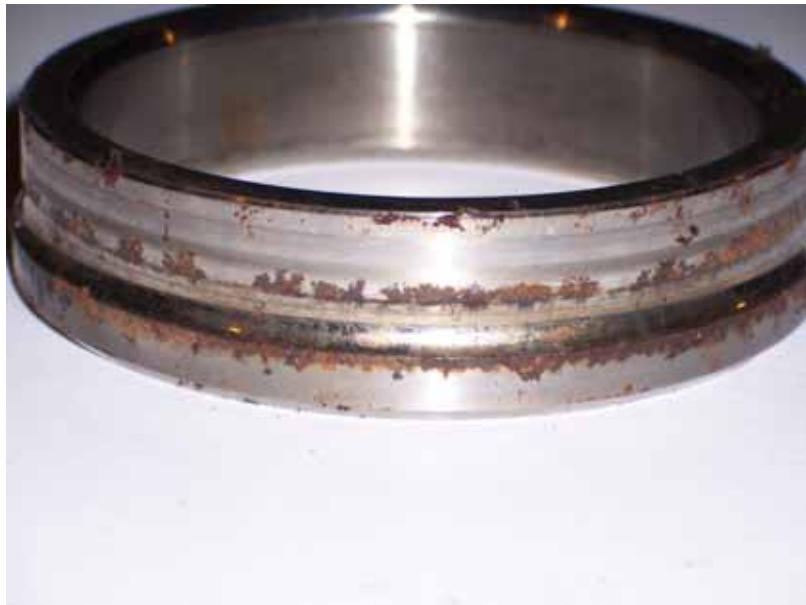
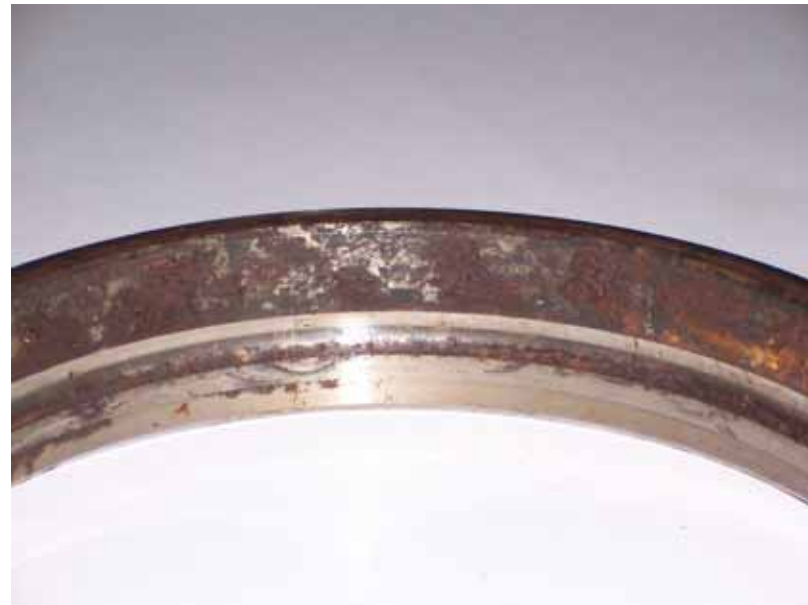
Bearings When Pulled

This is the condition of the spindle bearings after removing them. The coolant line had ruptured and purged all of the bearing grease out of the bearings. The coolant also continued running and caused the contamination and rust to develop.

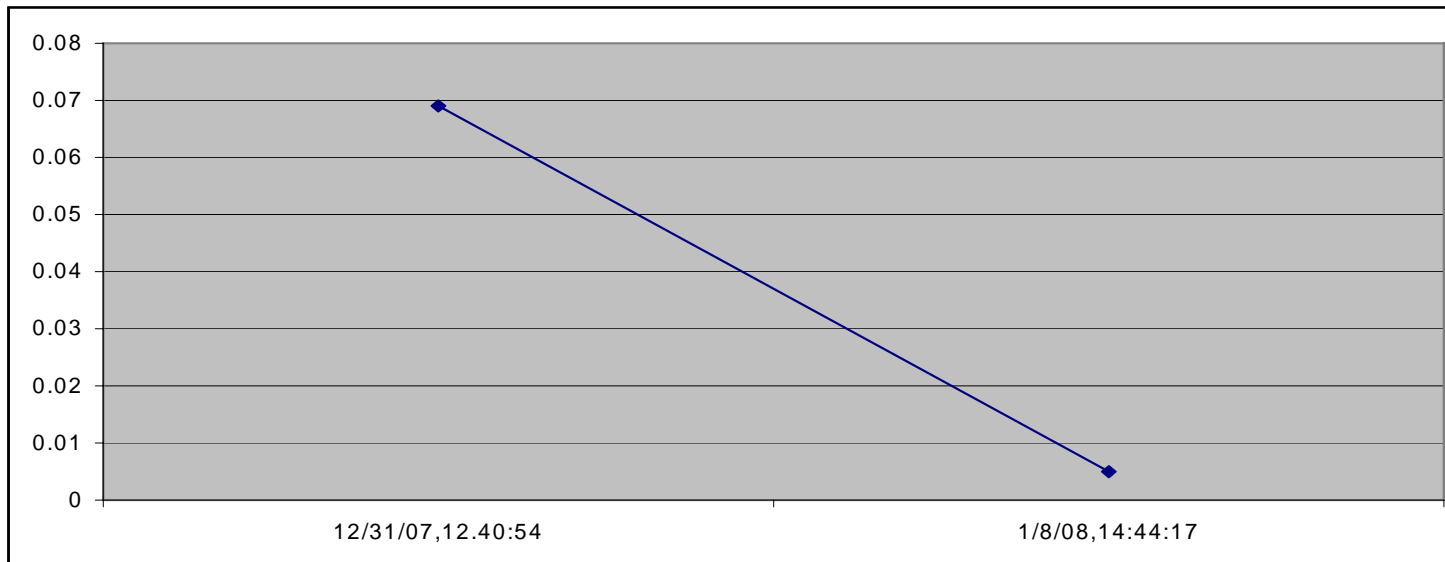
Vibration Data After Repair

After the repairs there was a 92% decrease in the Overall Vibration Levels on the lower spindle bearing.
