UTTER PRECISION, INC.

November 3, 2007

Subject: Plant Small Dust Collector Special Vibration Analysis

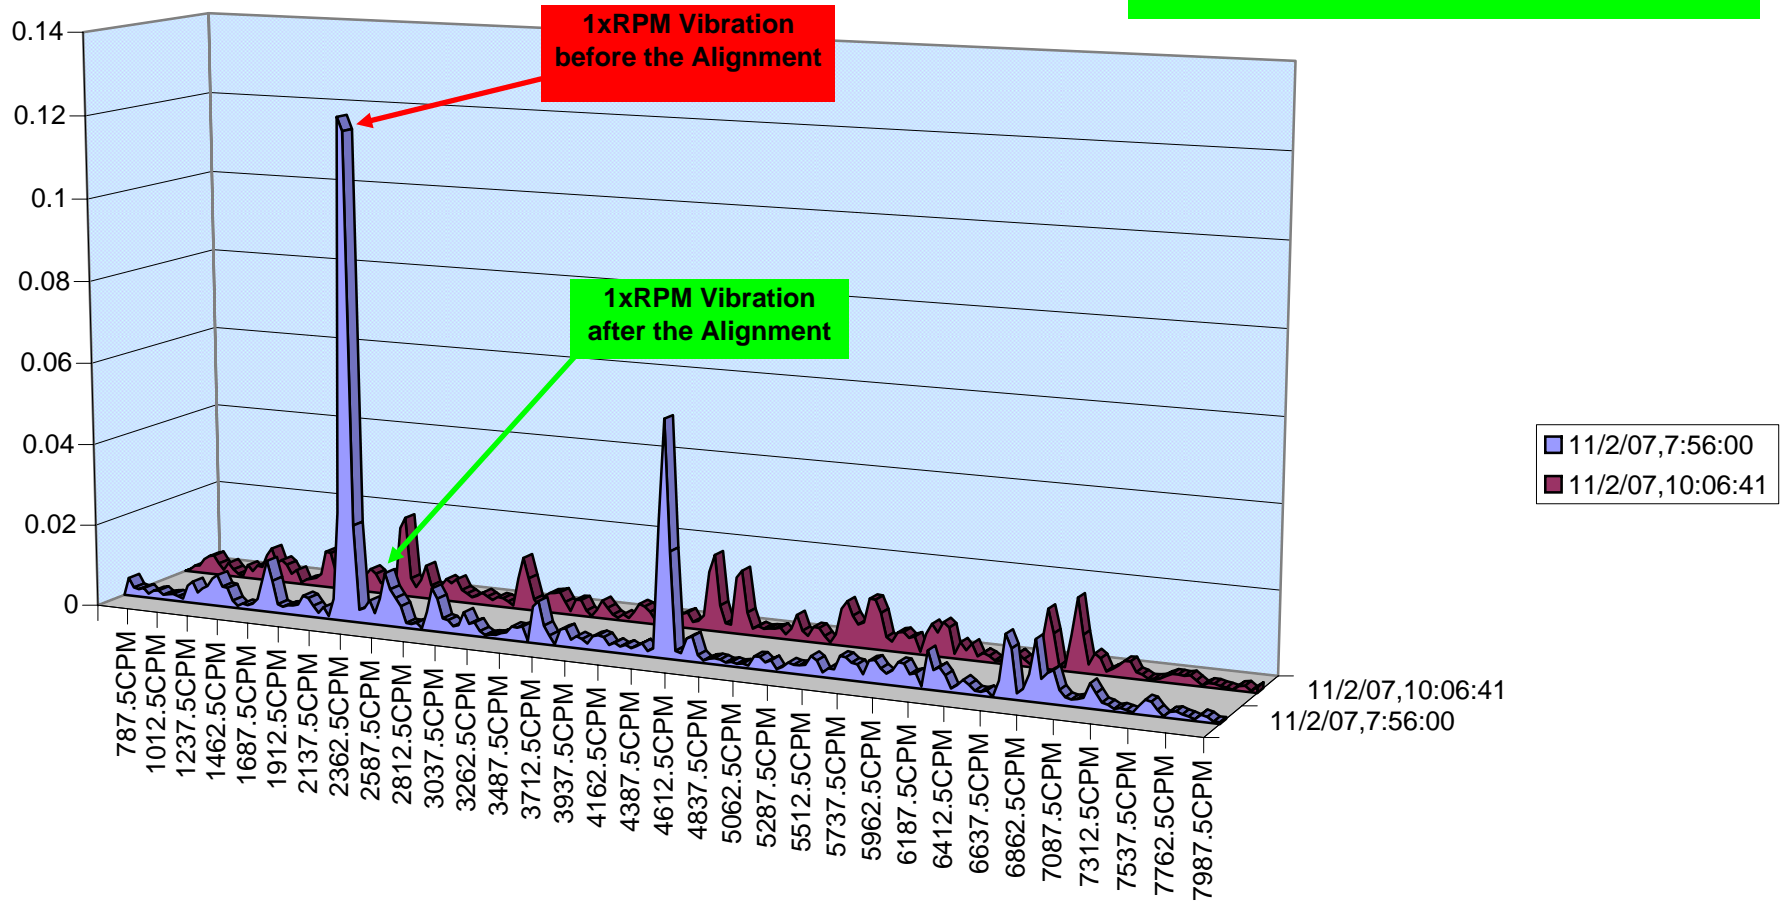
DCF-ia (in/s rms)

Vibration Levels on the Fan Unit improved significantly from the 7:56am reading in Blue which is before the alignment to the 10:06am reading in Purple after the alignment. Note the change in the 1xRPM peak shown by the arrows.

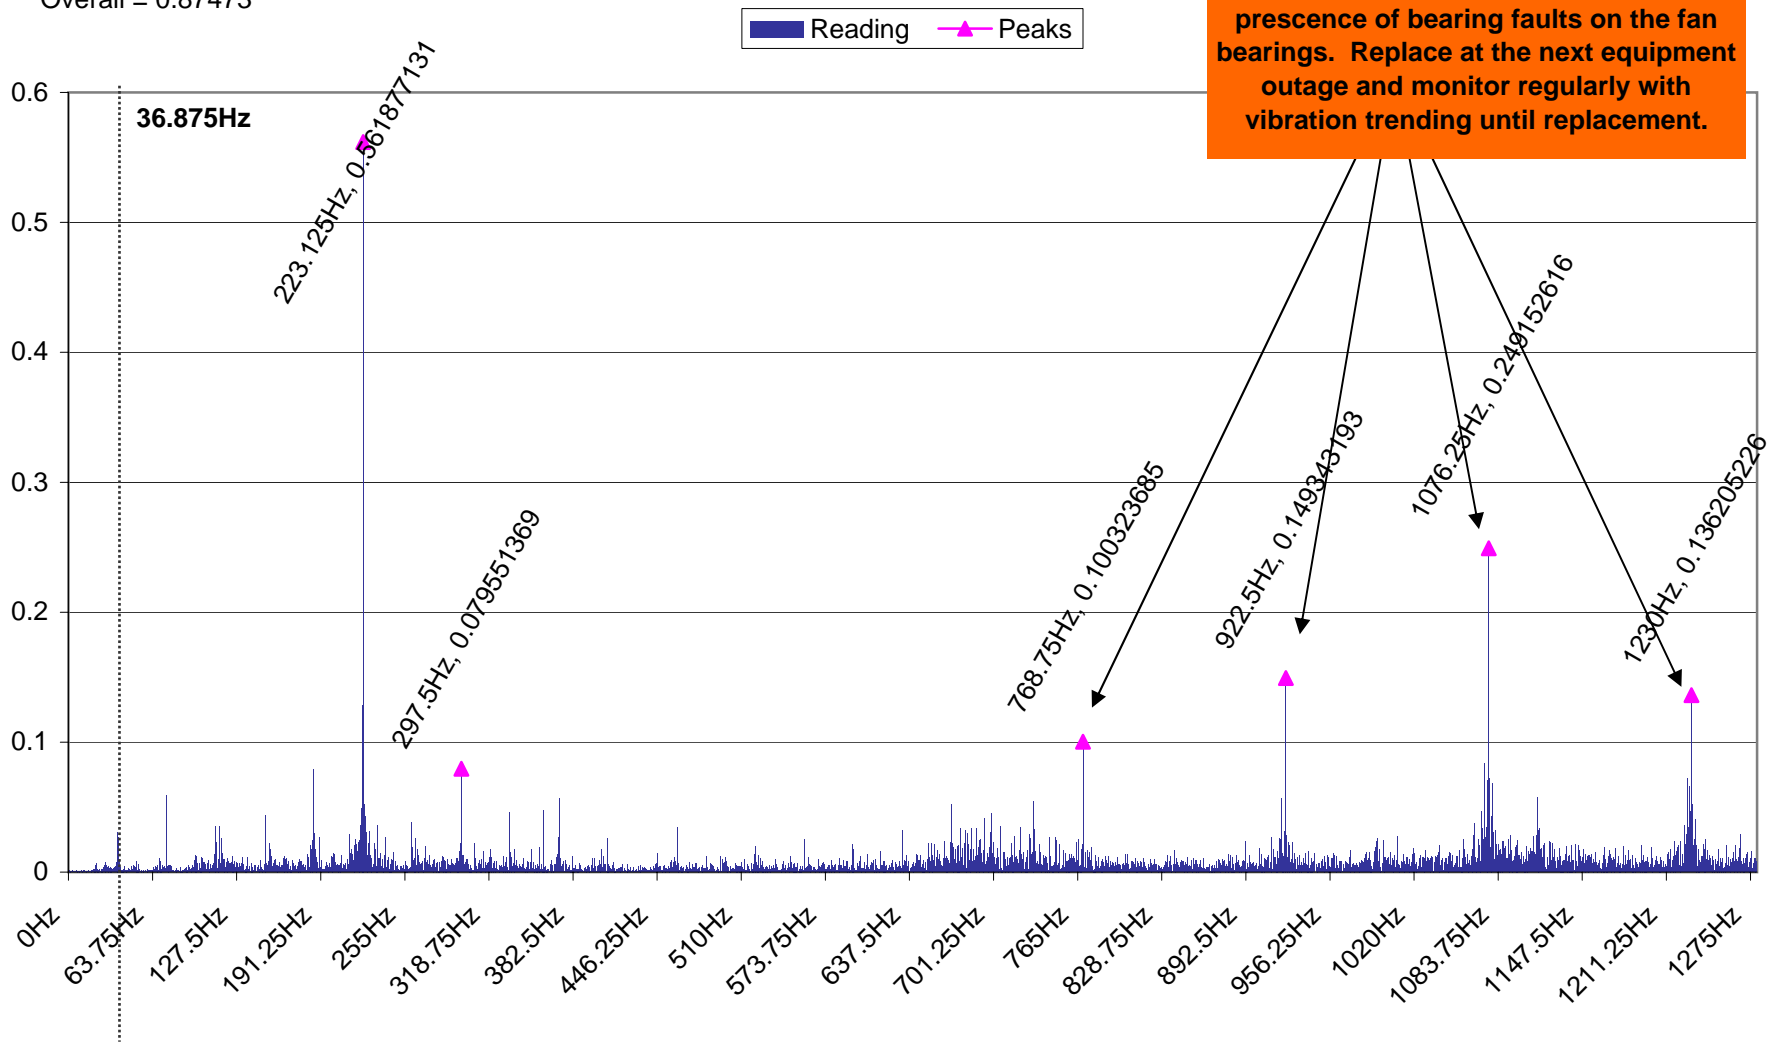
Acceleration
DCF-ihw (g) rms
Overall = 0.87473

Bearing numbers are unknown but the spacing of these peaks is 153.75Hz which is 5.72xRPM (1xRPM of the fan is 2212.5RPM or 36.875Hz). This and the impacting in the waveform shows the presence of bearing faults on the fan bearings. Replace at the next equipment outage and monitor regularly with vibration trending until replacement.

The belts were aligned and the bearings, sheaves, and belts were put on order but should be replaced when the next available opportunity arises. Until the replacement occurs ultrasonics and infrared can be quickly used to monitor the fan bearings. One of the maintenance guys used the ultrasonic gun to lubricate the bearings after the unit was started up and heard the levels on the bearing lower. This will allow the unit to run longer, but does not negate the need to replace the bearings.

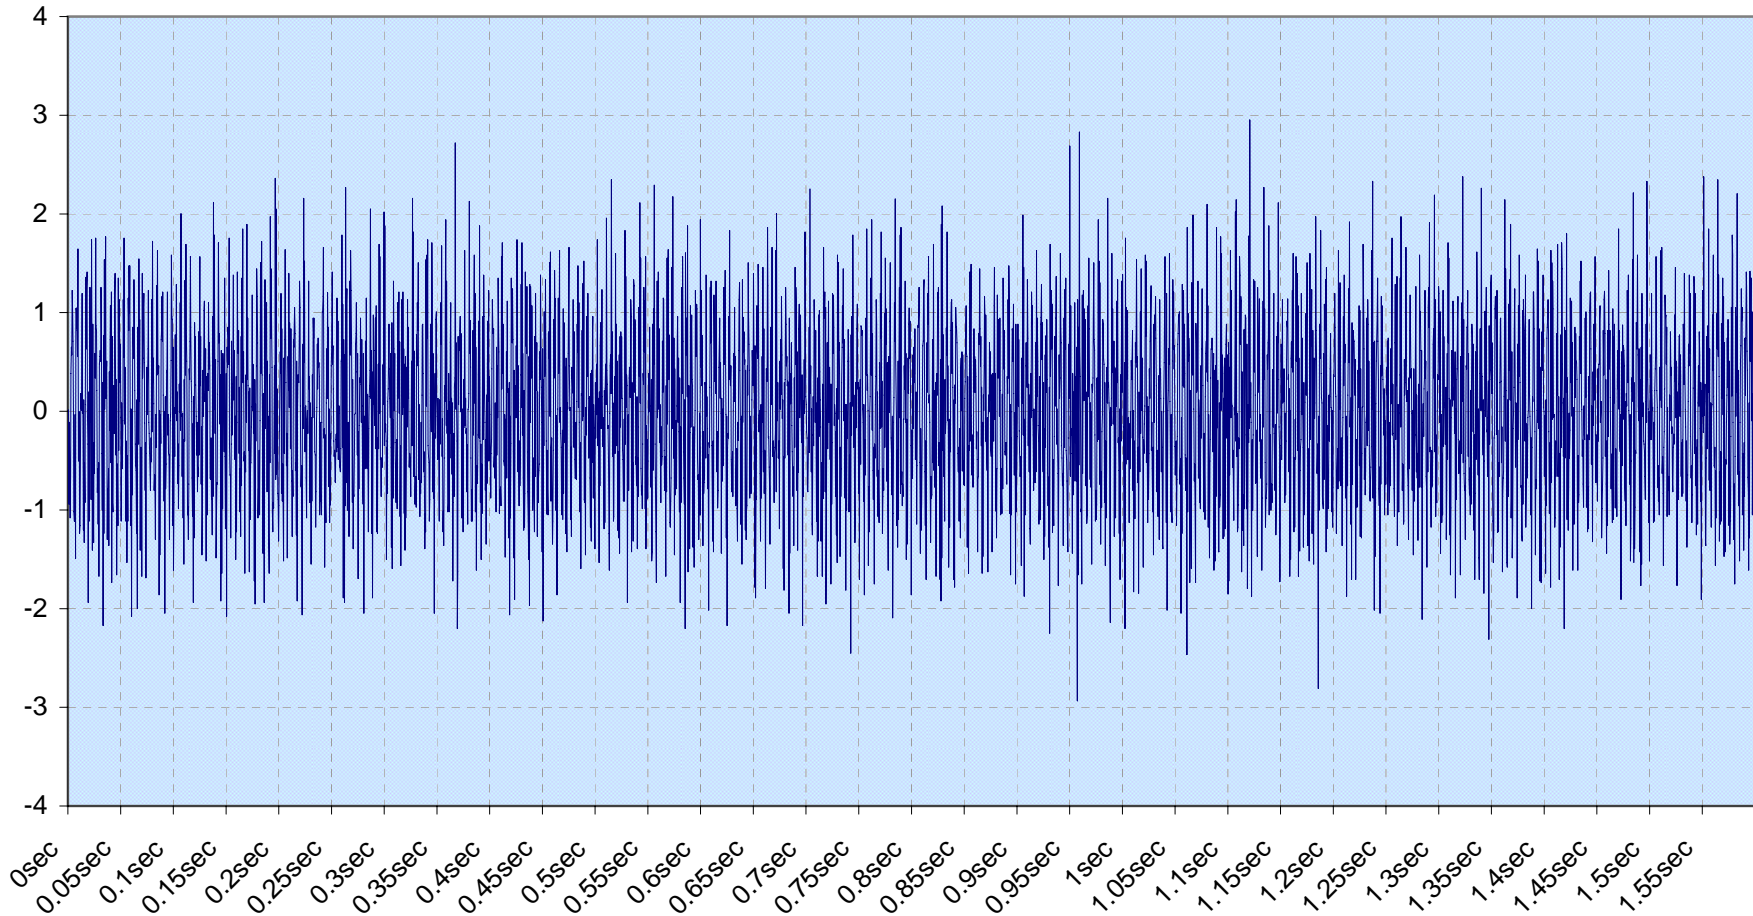
DCF-ihw (g)
Acceleration
Overall = 0.87501

Figure 2 shows the Peak to Peak Impacting of almost 6 G-s in the waveform is of concern but indicates that there is still life left in the bearings. Since the spectrum shows that the vibration is impacting is likely due to inner race defects the bearing should be closely watched until the replacement of the bearings

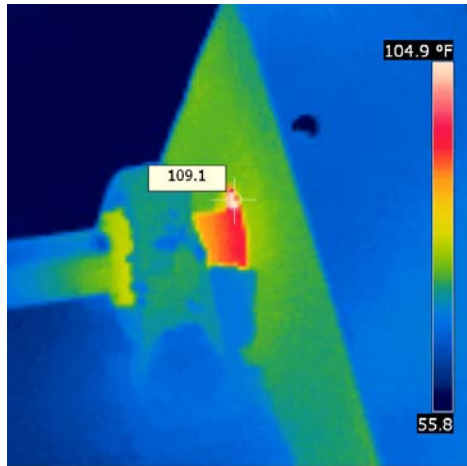
Heating of the Fan Sheave shown by the spot which indicates belt slippage. Also present is heating of the inner race of the bearing.

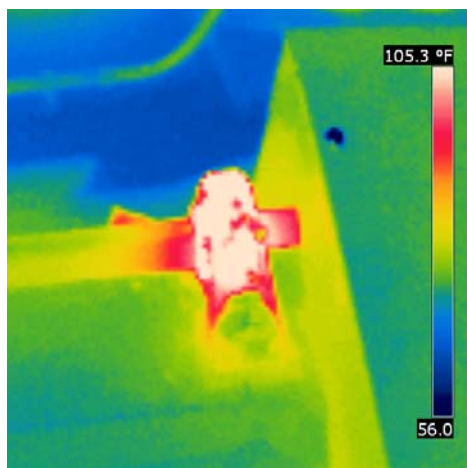
Heating of the bearing now is higher than that of the fan sheave. Also note that the heating goes from the bearing to the sheave instead of the other way due to the proper alignment. The bearing is hotter because it was just lubricated.

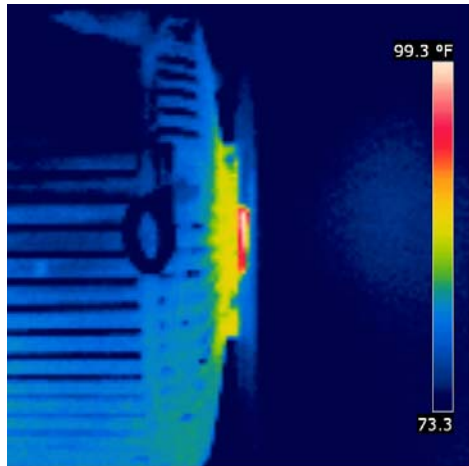
The Dust Collector Fan Motor showing the presence of heating of the drive end bearing which indicates a sheave misalignment issue is present.

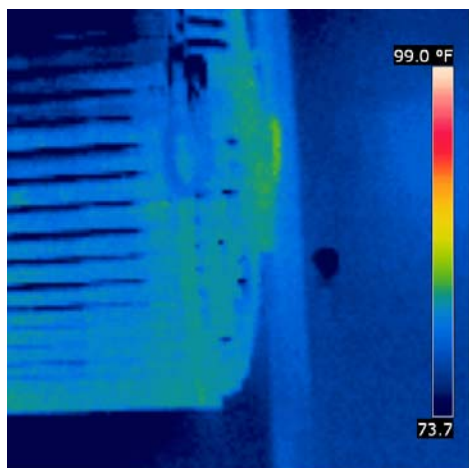
The after alignment picture showing the decrease in the load of the drive end shaft bearing.
