Waterfall Graph of DCF-ia

INSPECTION POINT TREND REPORT of DCF-ia

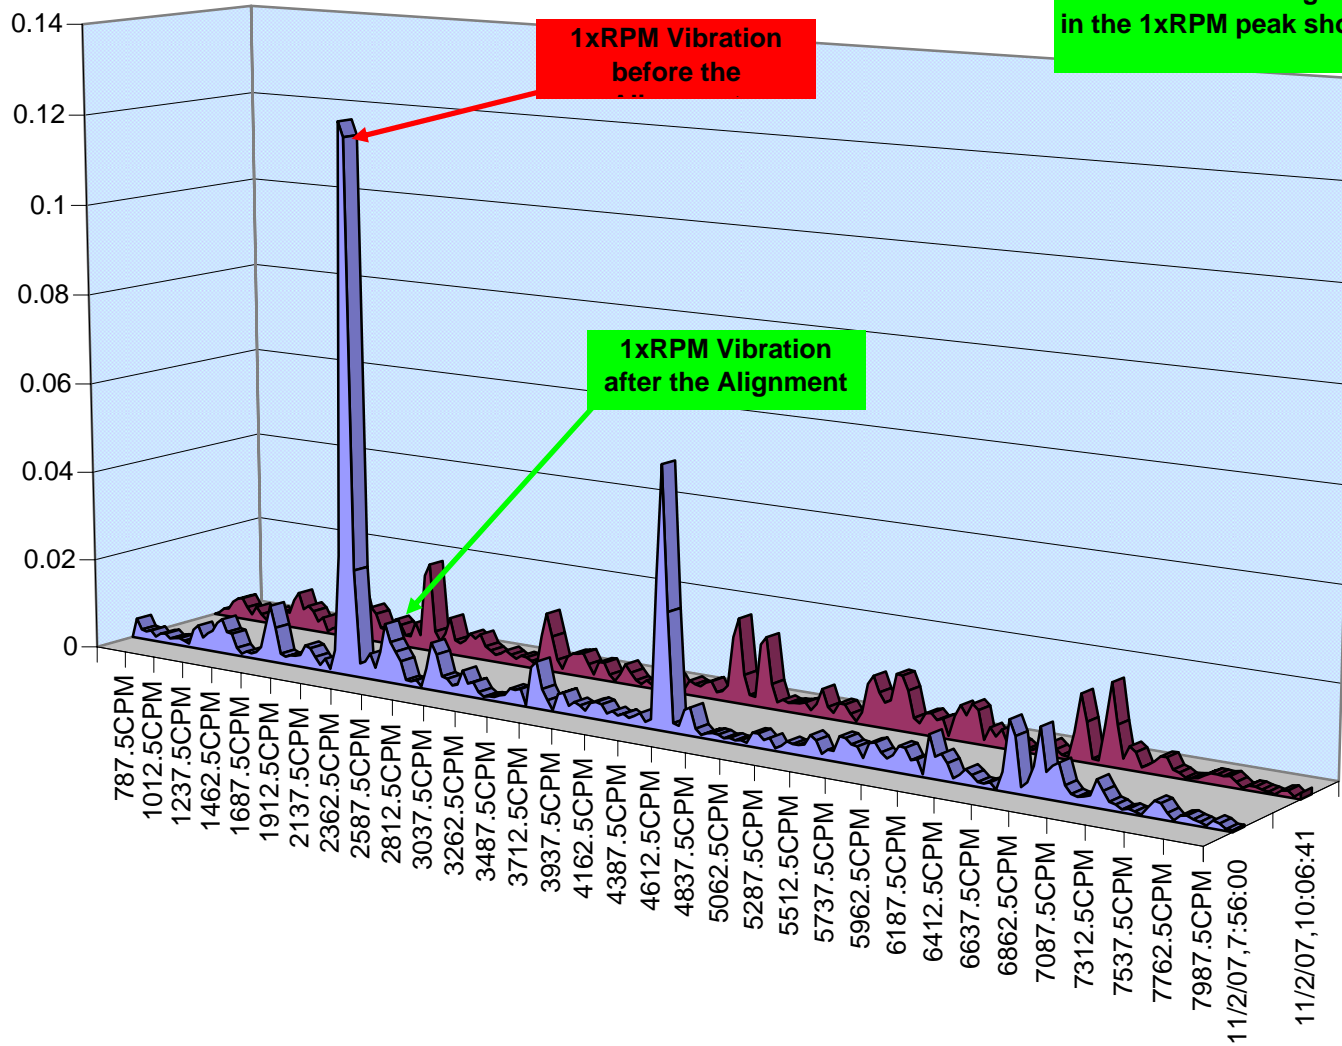
Vibration Levels on the Fan Unit Improved significantly from the 7:56am reading in Blue to the 10:06am reading in Purple. Note the change in the 1xRPM peak shown by the arrow.

1xRPM Vibration before the

1xRPM Vibration after the Alignment

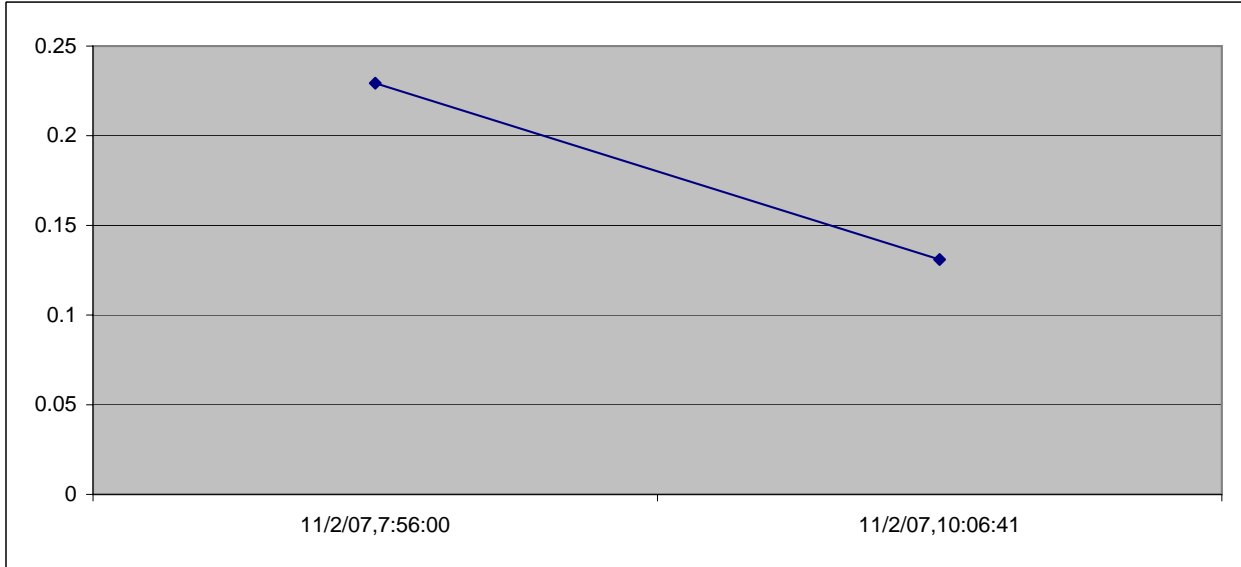
<u>Date/Time</u>	<u>Value</u>	<u>Units</u>	<u>Severity</u>
11/2/07,7:56:00	0.229272	in/s rms	Warning
11/2/07,10:06:41	0.131011	in/s rms	OK

The vibration levels decreased 42% on the fan after the alignment was performed. There still is the presence of bearing wear on the fan bearing and thus the vibration levels could be lower yet if the when the unit is proper repaired when the bearings are replaced. Continue normal vibration and infrared monitoring on a monthly basis.
