UTTER PRECISION, INC.

Vibration Case Study on a

Precision CNC Machine

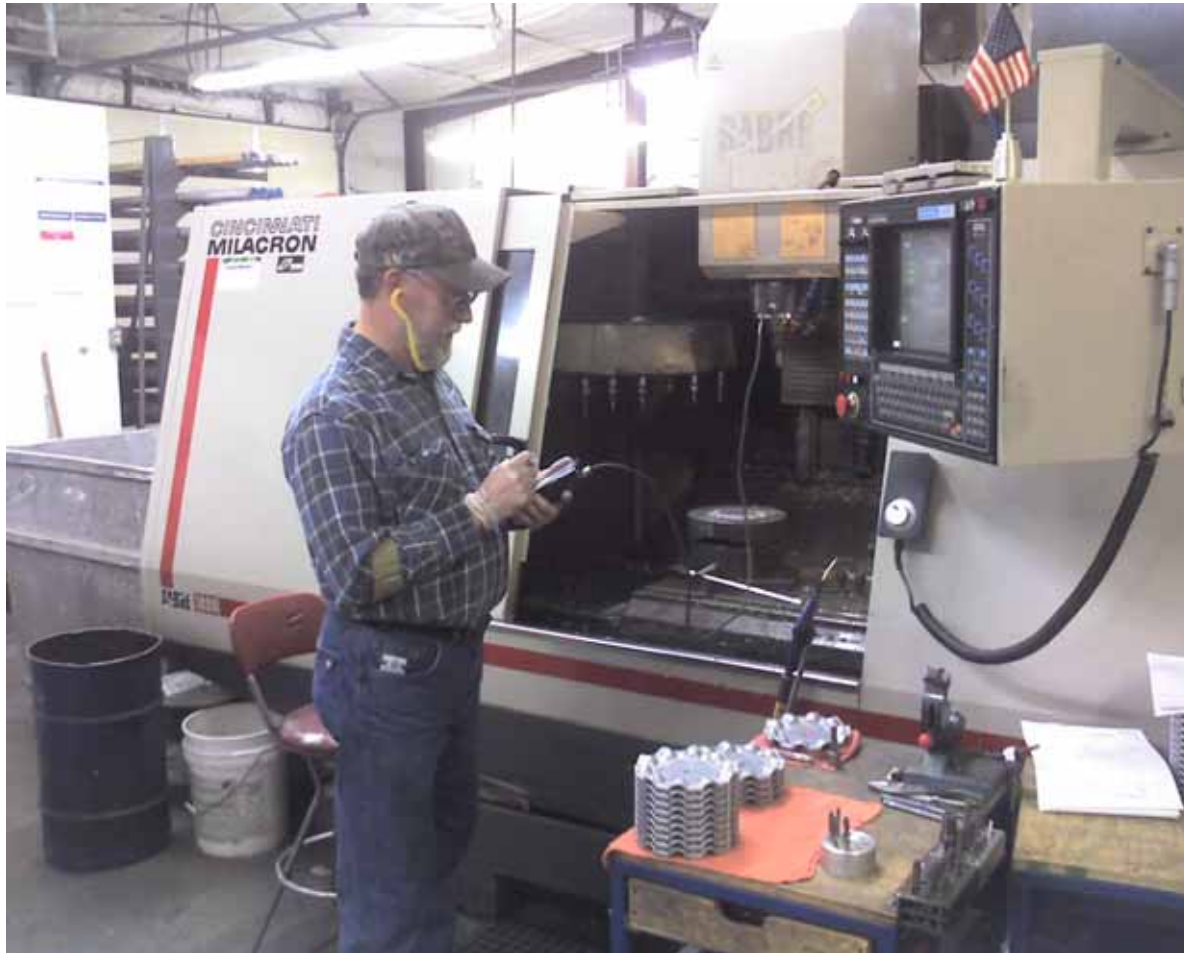
Machine Operator Taking Data

The Machine operator with minimal training was able to take readings.

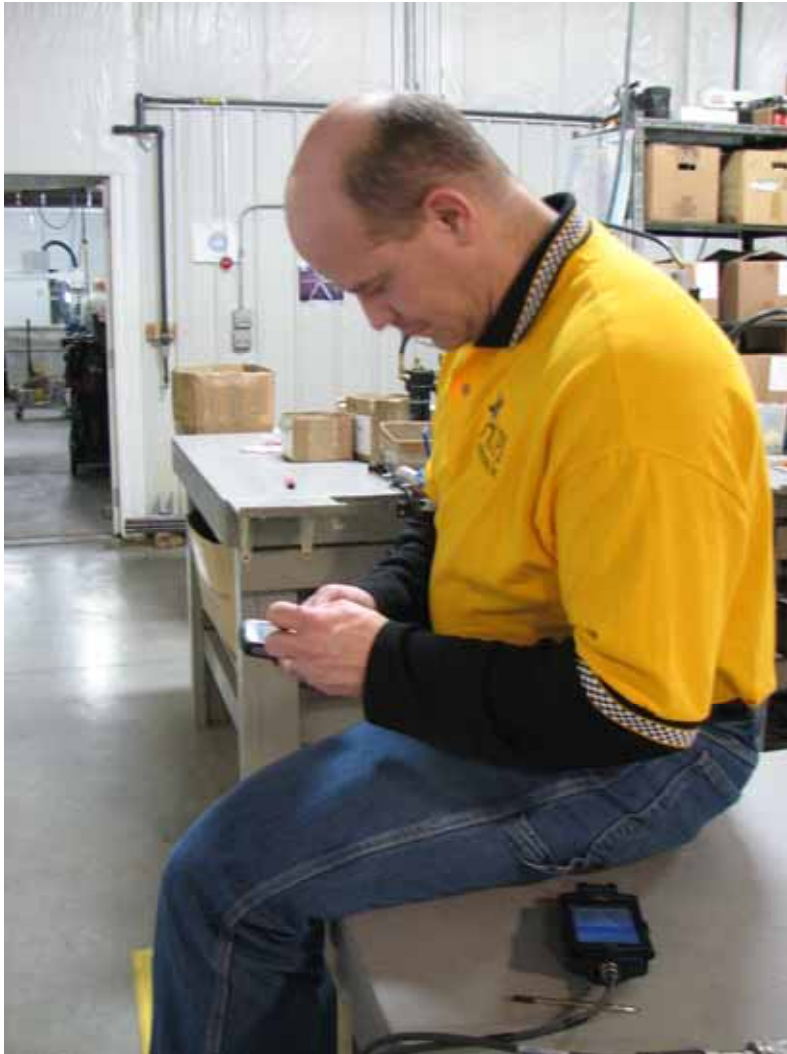
Me Analyzing the Data Elsewhere

Using the SiteConnex™ software on my Palm Treo, I received the Data and was able to analyze the condition of the bearing on both the spindle and the motor driving the CNC machine.

I then took a screen shot showing the issue and attached that to a return email stating the condition and giving repair recommendations so that a timely repair could be performed before the equipment failed.

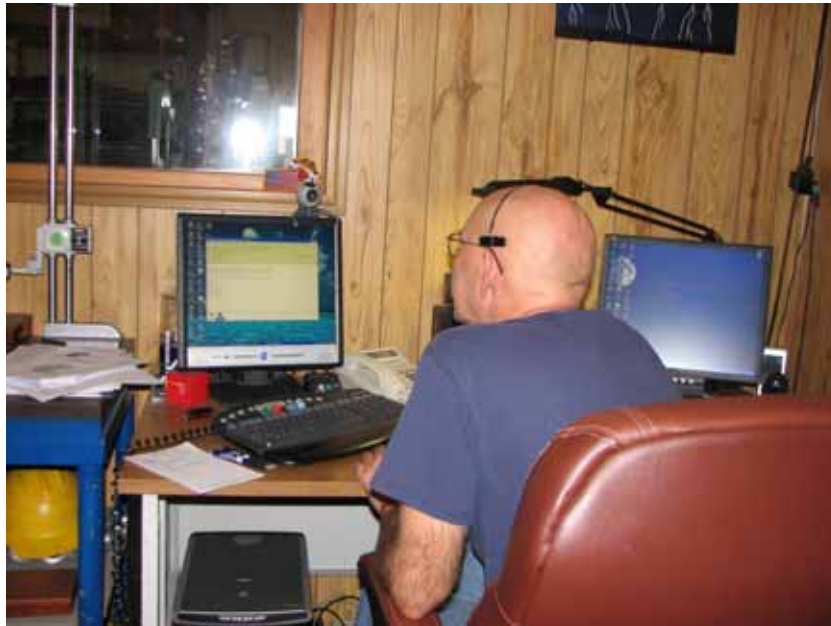
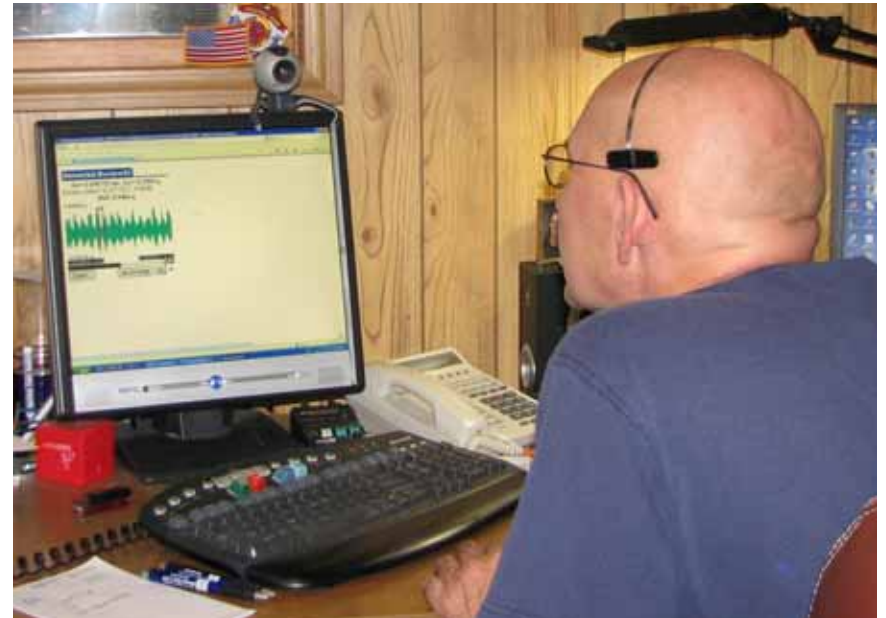
Owner Reviewing Emailed Analysis

The owner of the company received my email back in less than 15 minutes from sending it to me and was able to not only read my recommendations but also see the facts by viewing the screen shots.
