UTTER PRECISION, INC.

November 3, 2007

Subject: Plant Small Dust Collector Special Vibration Analysis

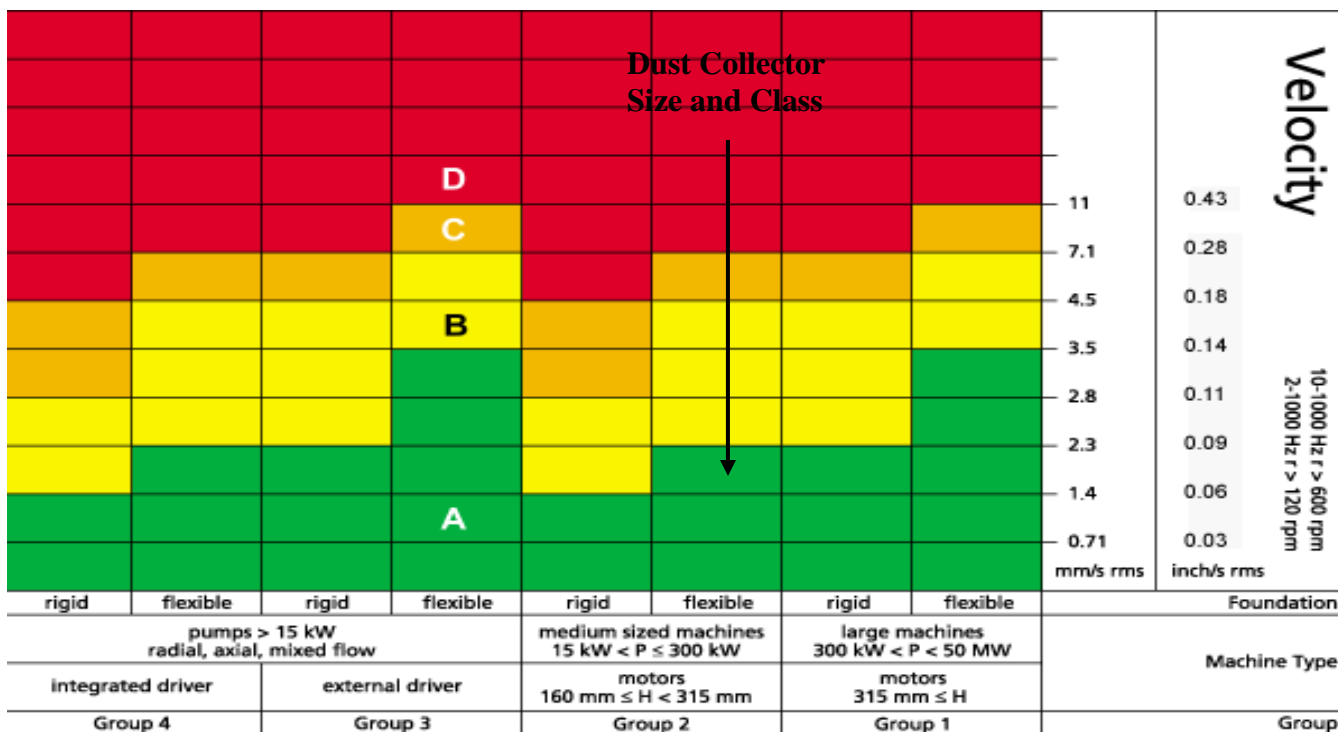
- A** New machine condition
- B** Unlimited long-term operation allowable
- C** Short-term operation allowable
- D** Vibration causes damage

The vibration on the fan showed numerous issues were present on the fan unit. I took vibration on the drive end bearing and found bearing faults present. We also found that the sheaves were misaligned.

The bearing wear is in Stage 2 of the bearing failure cycle and is considered to be at **Short Term Allowable Level** due to the type of vibration that is present. This is shown by Figures 1 & 2. Figure 3 & 4 show the before and after affects from the belt alignment that was performed.

The belts were aligned and the bearings, sheaves, and belts were put on order but should be replaced when the next available opportunity arises. Until the replacement occurs ultrasonics and infrared can be quickly used to monitor the fan bearings. One of the maintenance guys used the ultrasonic gun to lubricate the bearings after the unit was started up and heard the levels on the bearing lower. This will allow the unit to run longer, but does not negate the need to replace the bearings.
